# Manhole Inspection Summary

Manhole # S15C\_\_064MH

**Location** Address: **EVERGREEN ST** Cross Street: **W. FRANKLIN ST**

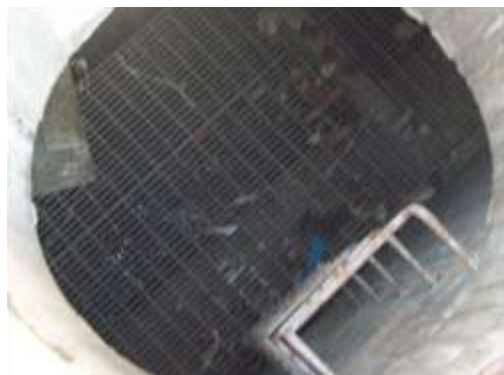
Top View

Comments **STEEL GRADE COVERING THE ENTIRE BOTTOM OF THE MANHOLE**
